**DISTRICT RECORD**

New Montgomery, Mission & Second Historic DistrictD1. Historic Name South of Market AreaD2. Common Name: Transit Center District

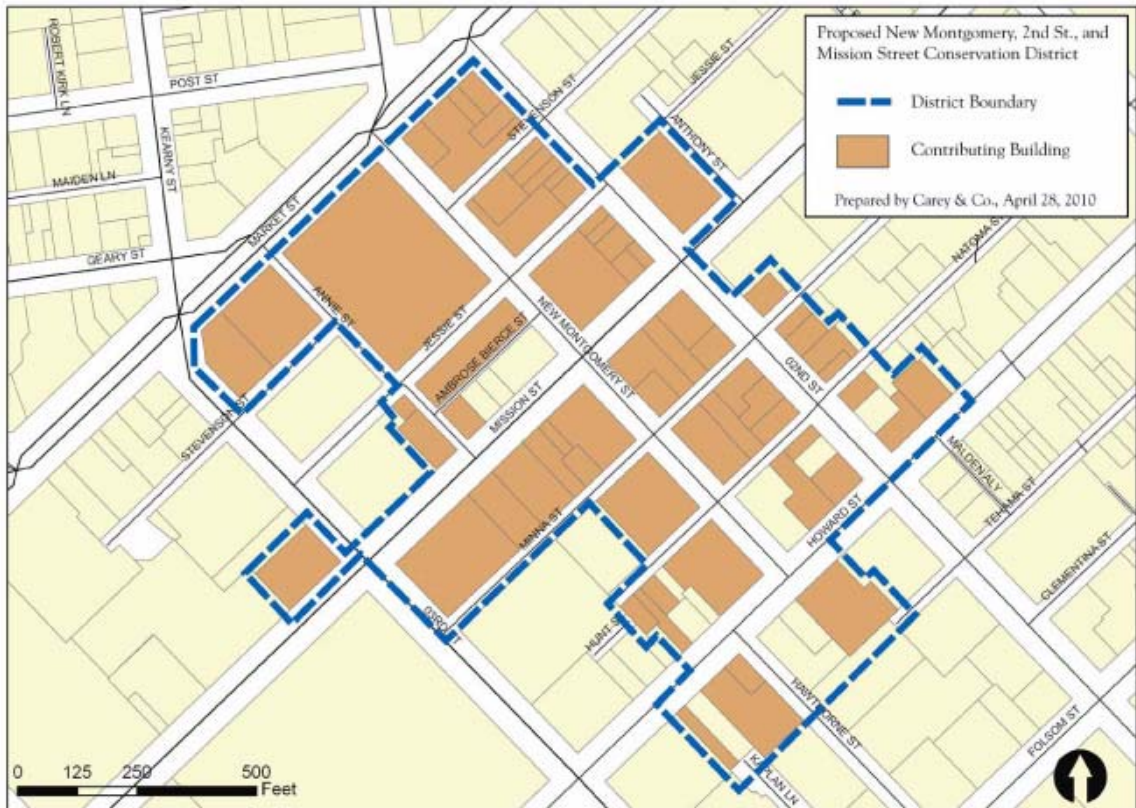
**Figure 1. Boundaries of proposed New Montgomery, Mission & Second Historic District**  
**Source: Carey & Company**

The proposed New Montgomery, Mission & Second Historic District is roughly L-shaped and centered on the intersection of New Montgomery and Mission Streets in San Francisco’s South of Market Area. The proposed district is composed of 77 parcels encompassing 64 contributing resources and 13 non-contributing resources. The contributors are identified on the Department of Parks and Recreation (DPR) 523 A (Primary) forms created as part of the accompanying Transit Center District Plan Survey. A list of all contributors is also included in **Table 1** and non-contributors are listed in **Table 2**.

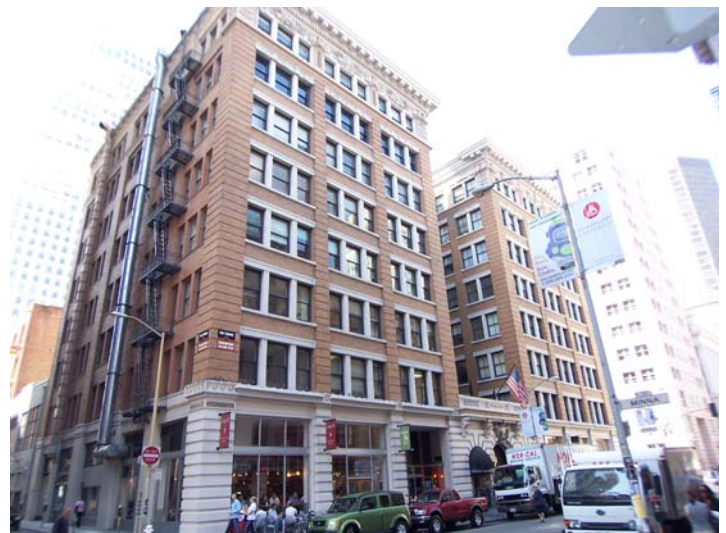
Figure 2. Rialto Building, 2007

warehouses. Some were pre-quake survivors such as the Wells Fargo Building at 71-85 2<sup>nd</sup> Street, which was restored in 1907. By 1908, the Aronson Building, which still stands at 700 Mission Street, was outfitted with a new interior. The Sharon Estate, owners of the Palace Hotel at Market and New Montgomery, decided to demolish the shell of the original 1873 hotel and replace it with an entirely new modern structure designed by the New York firm of Trowbridge & Livingston in 1909. In contrast, the owners of the more heavily damaged Rialto Building, constructed in 1902 according to plans drawn up by Meyer & O'Brien, decided to repair their fire-gutted building (**Figure 2**).

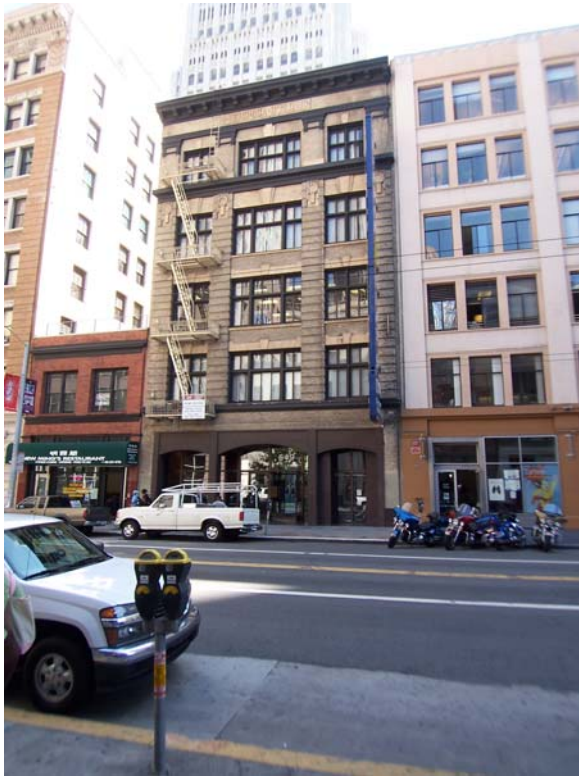
Figure 3. Veronica Building, 2007

Many more buildings within the historic district were newly constructed between 1906 and 1910. The vast majority were designed in the American Commercial style with spare Renaissance-Baroque ornamentation. Substantial concentrations of these buildings, most ranging between three and seven stories and of steel or heavy timber frame construction, went up in rapid succession along 2<sup>nd</sup>, Howard, and Mission Streets. Although built on a budget, most were architect-designed and of high-quality if mass-produced materials. Examples include the Kentfield & Esser Building at 48 2<sup>nd</sup> Street (1907), the Drexler Estate Building at 121 2<sup>nd</sup> Street (1907), the Mercedes Building at 531 Howard Street (1906), and the Veronica Building at 647 Mission Street (1947) (**Figure 3**).

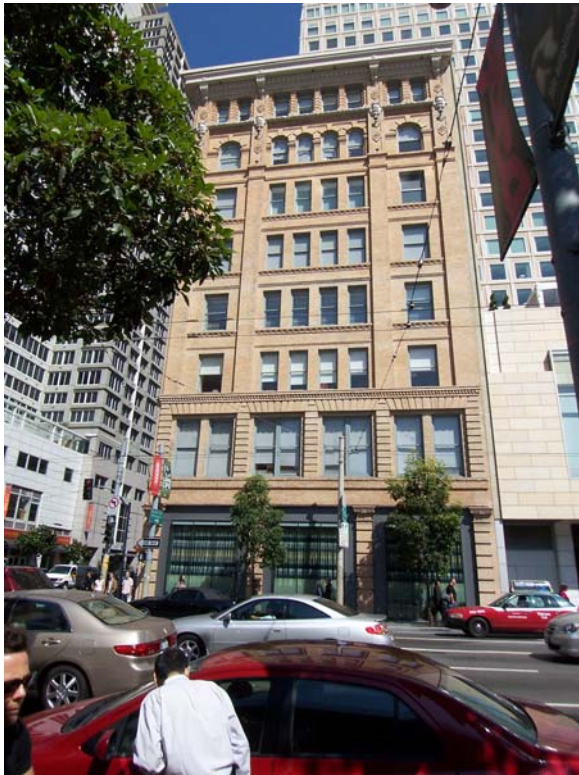
Figure 5. Williams Building, 2007

The continued integration of the South of Market Area into the central business district between 1906 and 1929 is reflected in several skyscrapers built along both Mission and Market Streets between 1906 and 1910, including the Metropolitan Trust and Savings Bank at 625 Market Street (1907), the Hearst Building at 691 Market Street (1909), and the Spreckels Building at 703 Market Street (1898, rebuilt 1907). The intersection of 3<sup>rd</sup> and Mission evolved into another important locus of building activity in the district, eventually bracketed on three corners by important early skyscrapers, including the rebuilt Aronson Building on the northwest corner of 3<sup>rd</sup> and Mission (1903, rebuilt 1907) and the Williams Building on the opposite corner (1907) (**Figure 5**).<sup>3</sup>
